**CHRISTOPHER P. WILLIAMS ARCHITECTS, PLLC**  
**PO Box 703 · Meredith, New Hampshire 03253 · 603-279-6513**

**Historic Building Assessment with Preservation Guidelines**

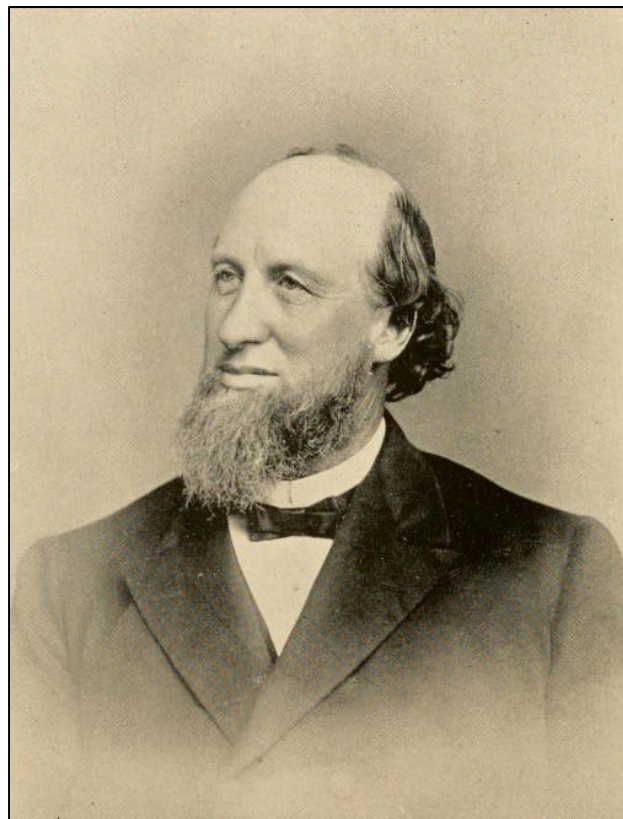
Figure 3: Philip A. Butler (from *History of the Town of Candia*, 304)

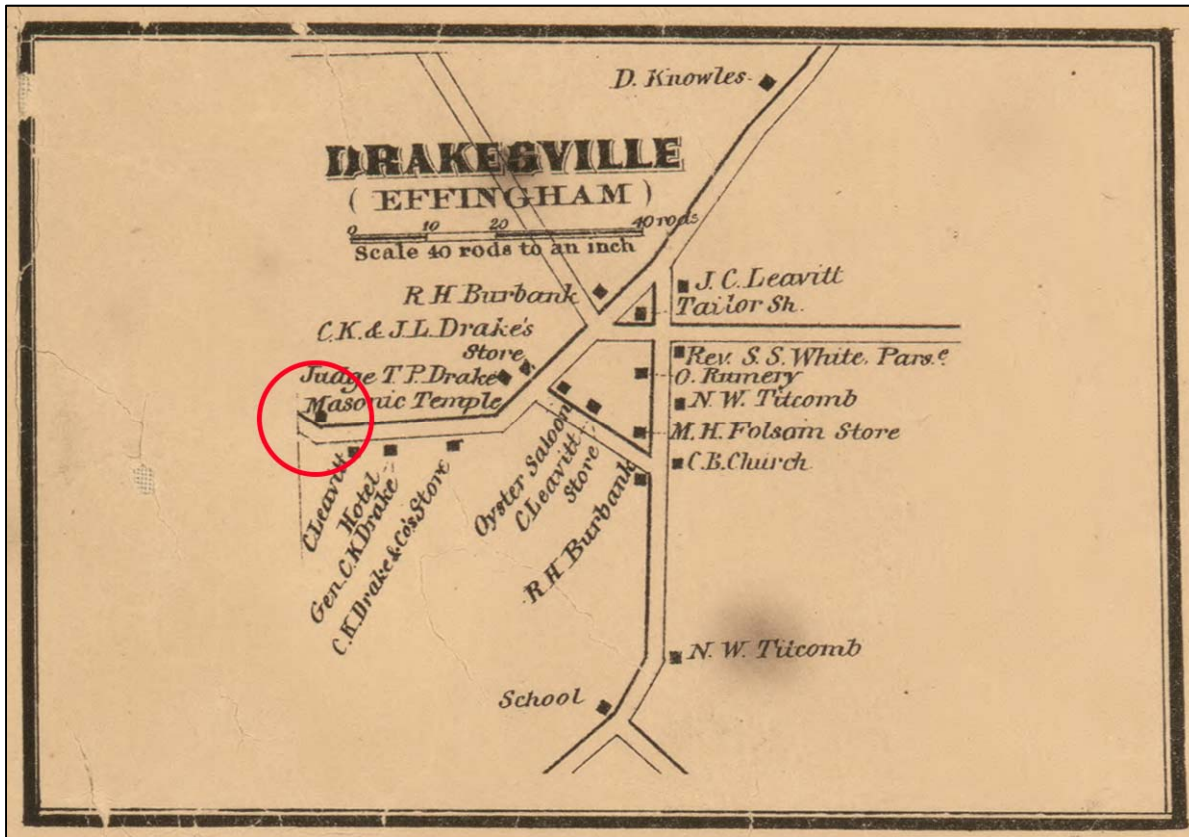
Figure 5: Drakesville/Drake's Corner, Effingham in 1861 (E. M. Woodford "Topographical Map of Carroll County.")

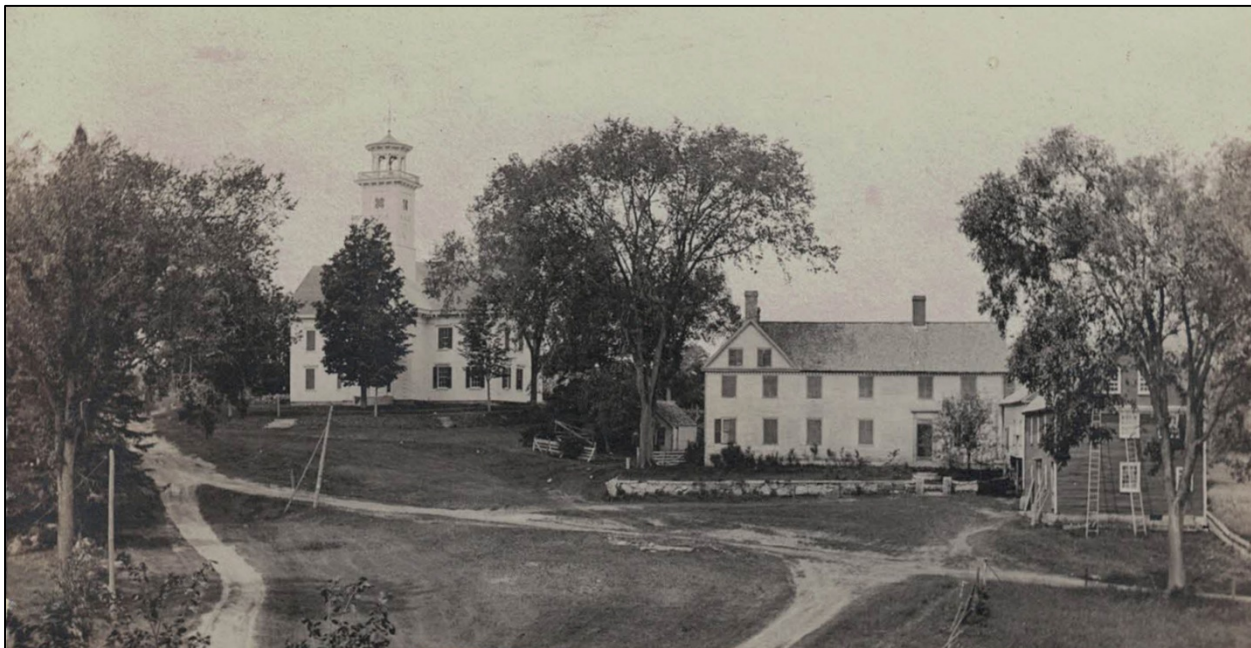
Figure 10: Masonic Hall and Thomas P. Drake House ca. 1920 (Collection of the Effingham Historical Society)

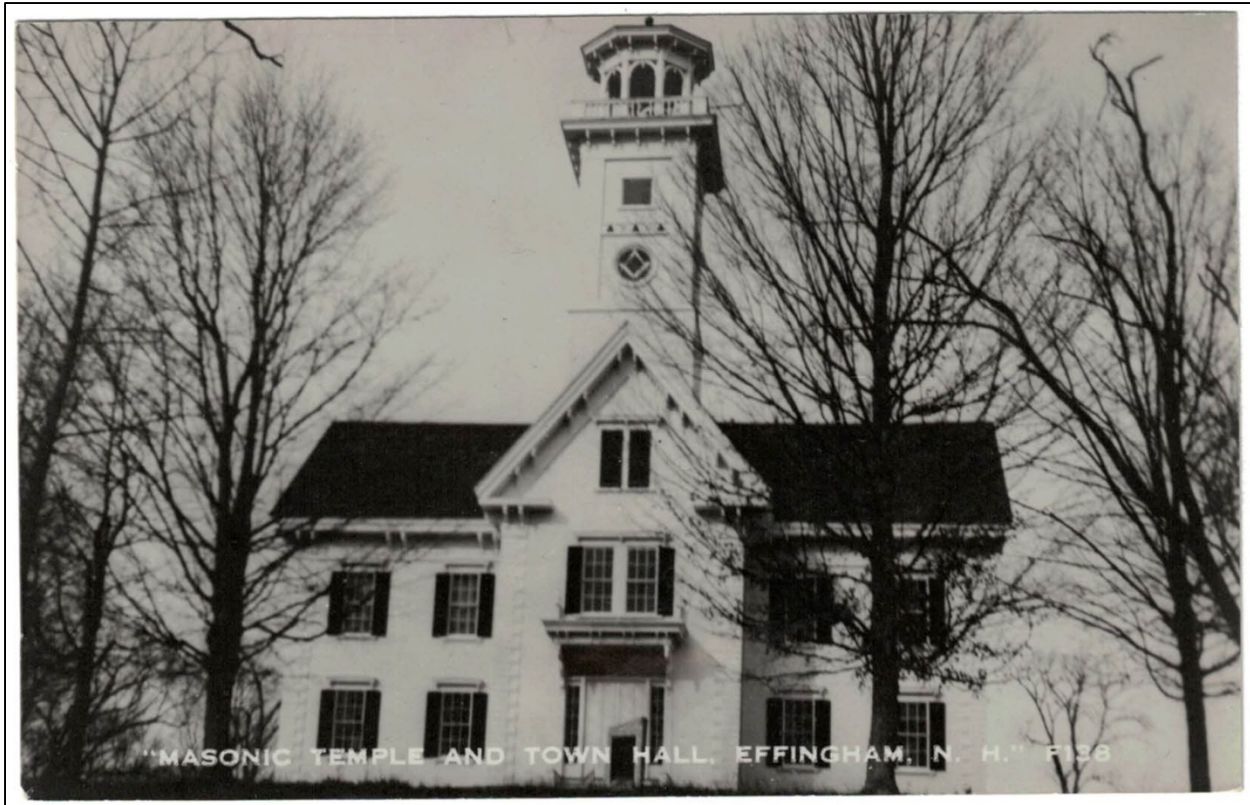
**Figure 11: The quatrefoil windows of the bell tower replaced by the time of this undated photograph (Collections of the Effingham Historical Society)**

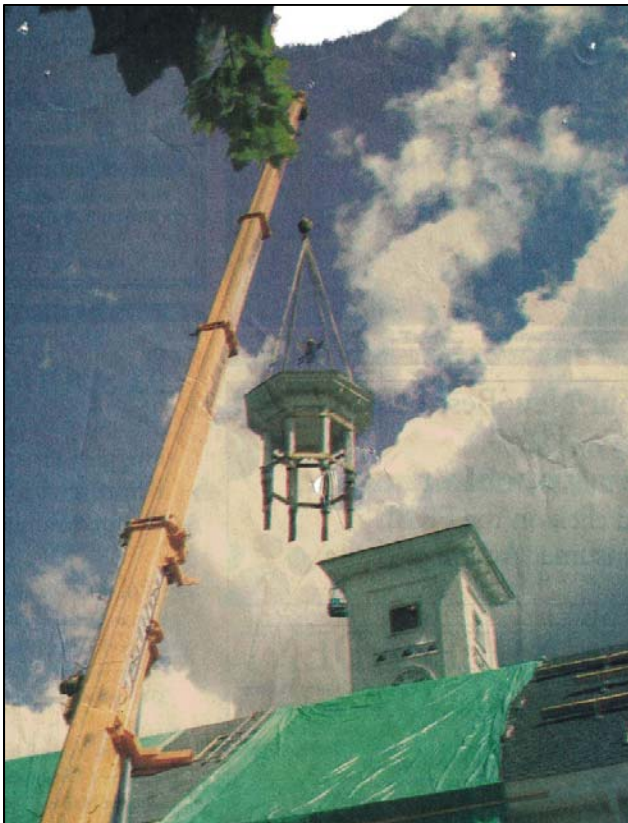
Figure 12: Removal of Belfry in 2006 (Newspaper Clipping in Collection of the Effingham Historical Society)

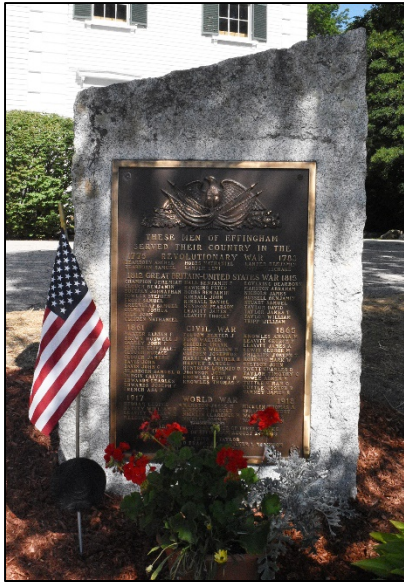
Figure 14: 1933 Veteran's Memorial

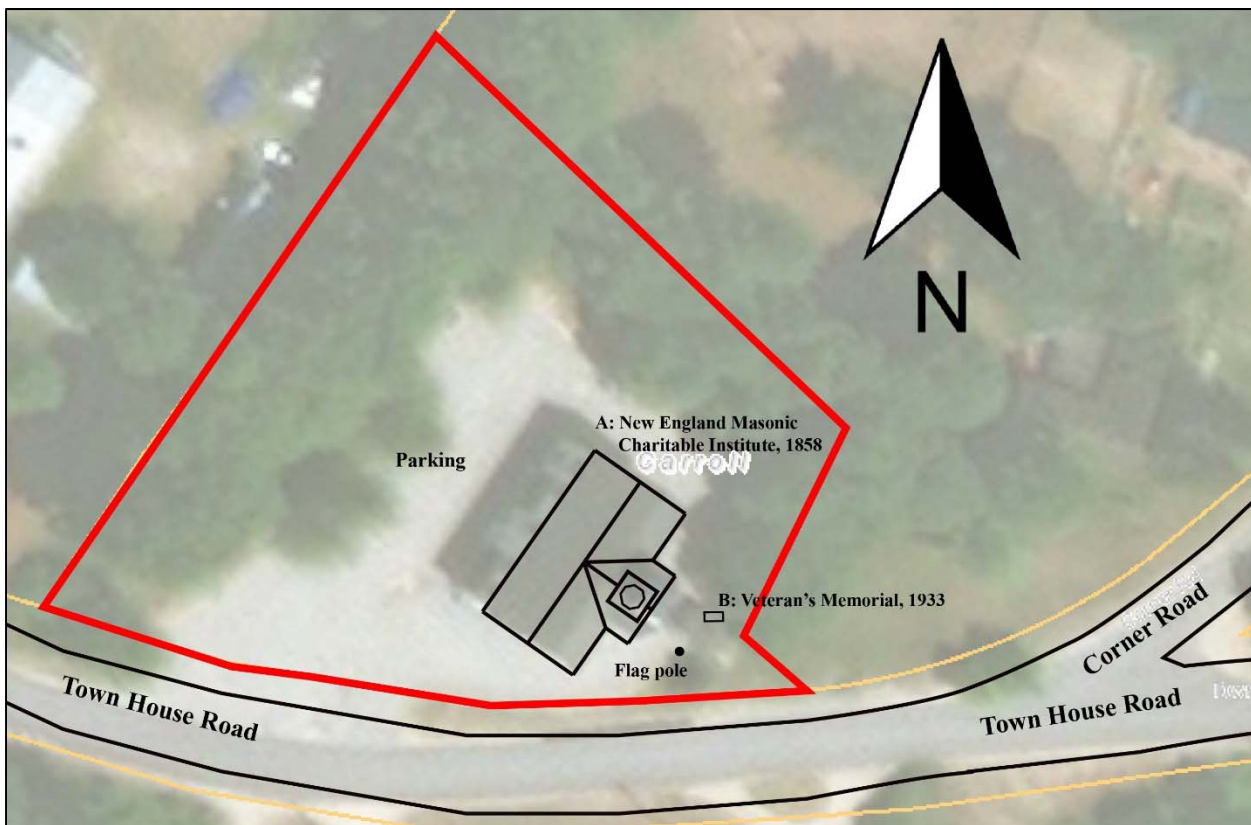
Figure 15: Location of the New England Masonic Charitable Institute

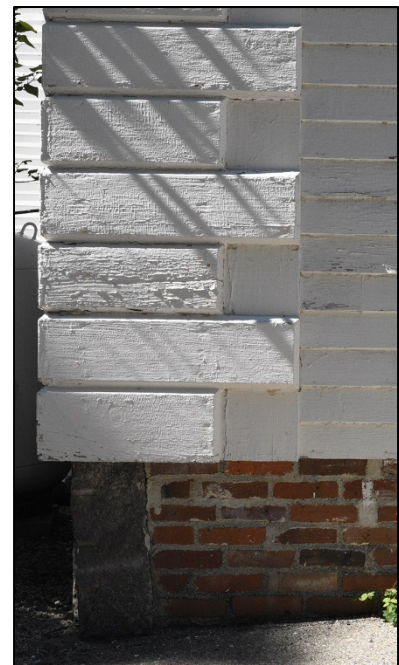
**Figure 17: Detail of foundation**

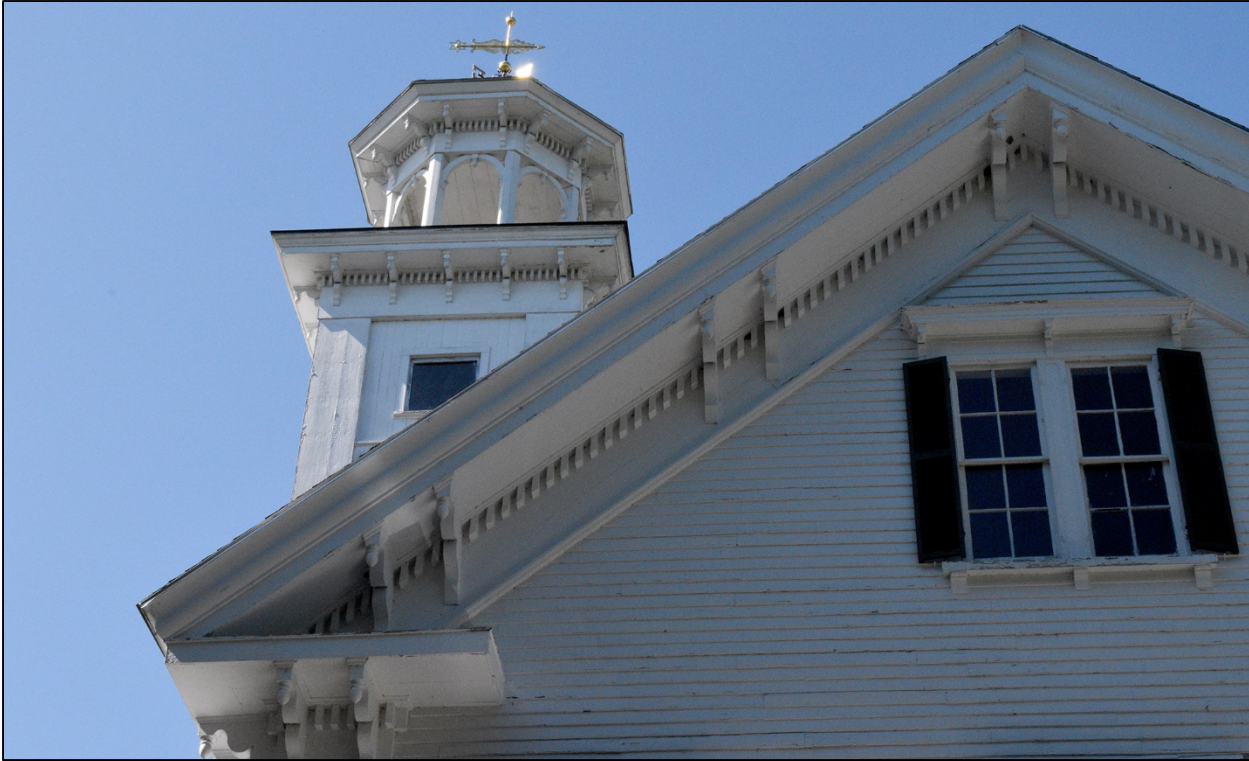
**Figure 18: Detail of eave ornamentation**

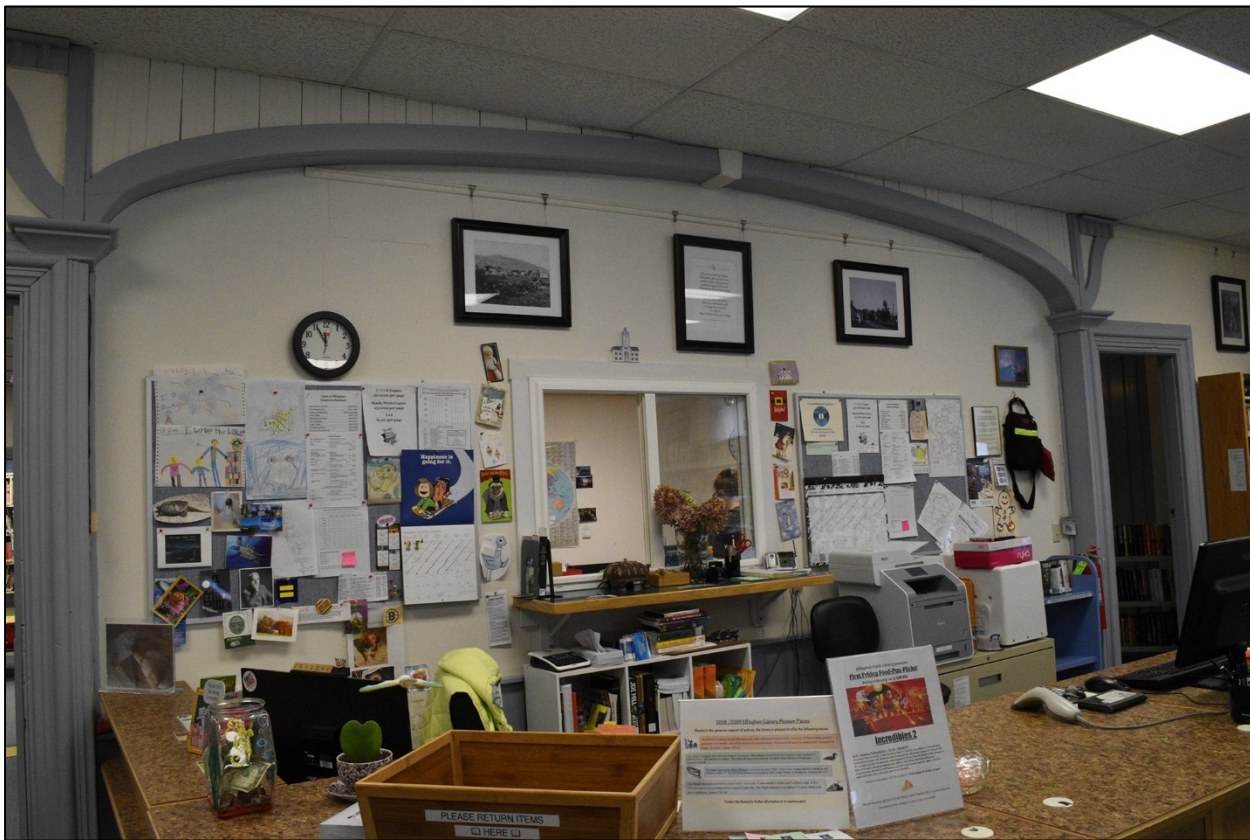
**Figure 24: Proscenium in West Room**

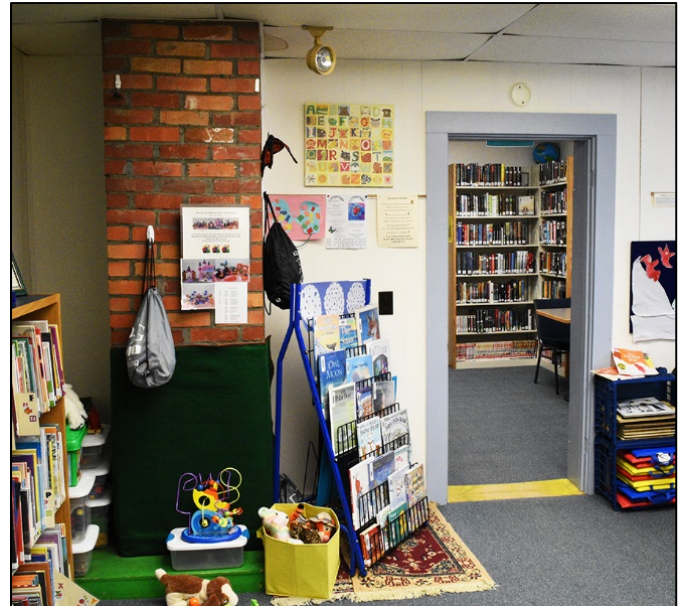
Figure 26: Exposed chimney in Children's Room

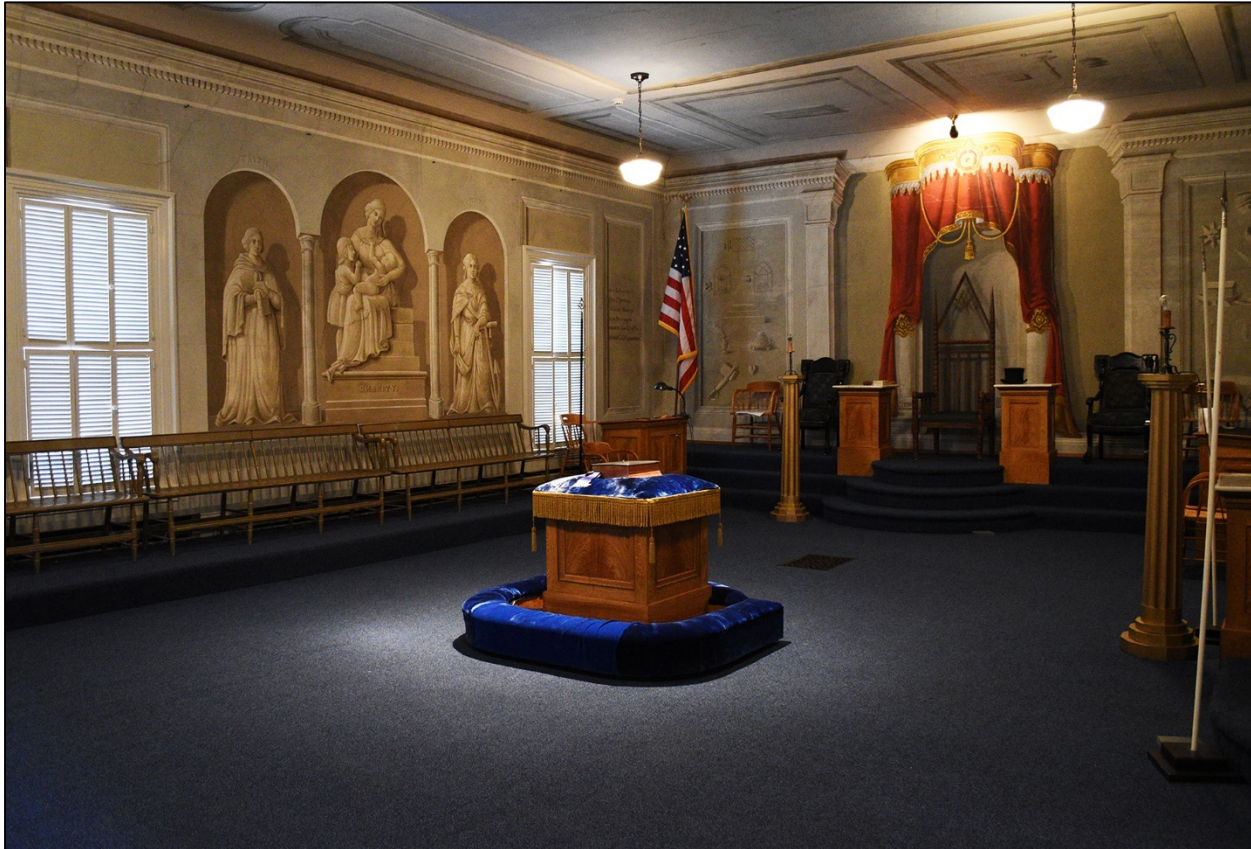
**Figure 31: Masonic Hall, facing North**

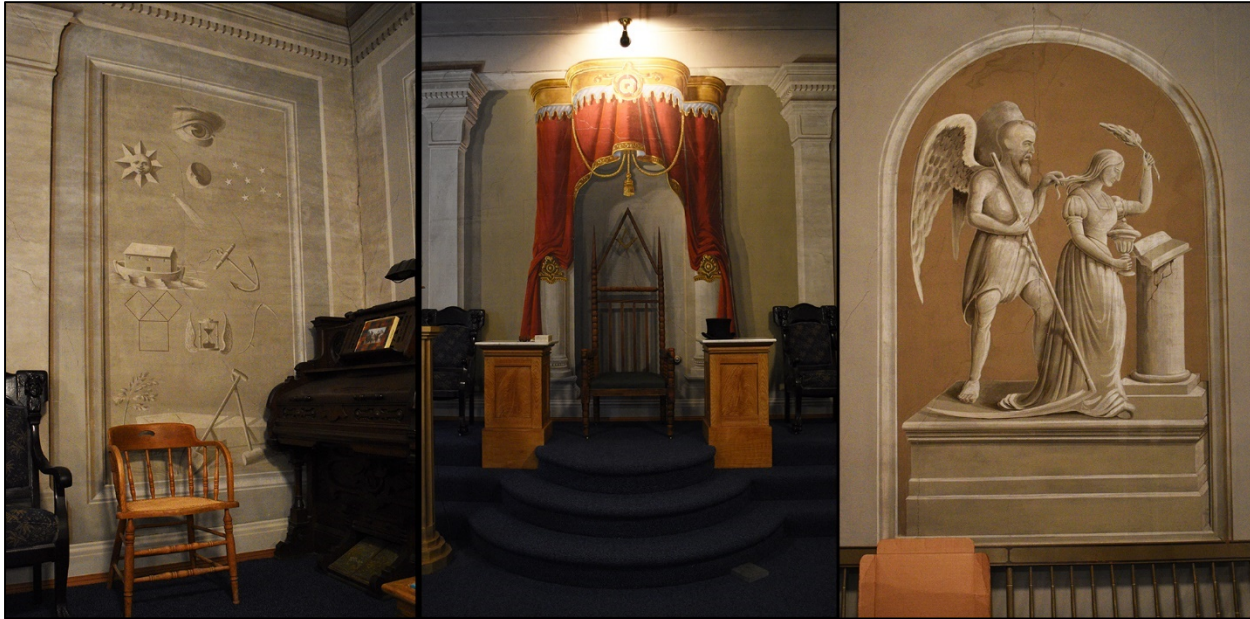
Figure 32: Example Masonic Hall panels

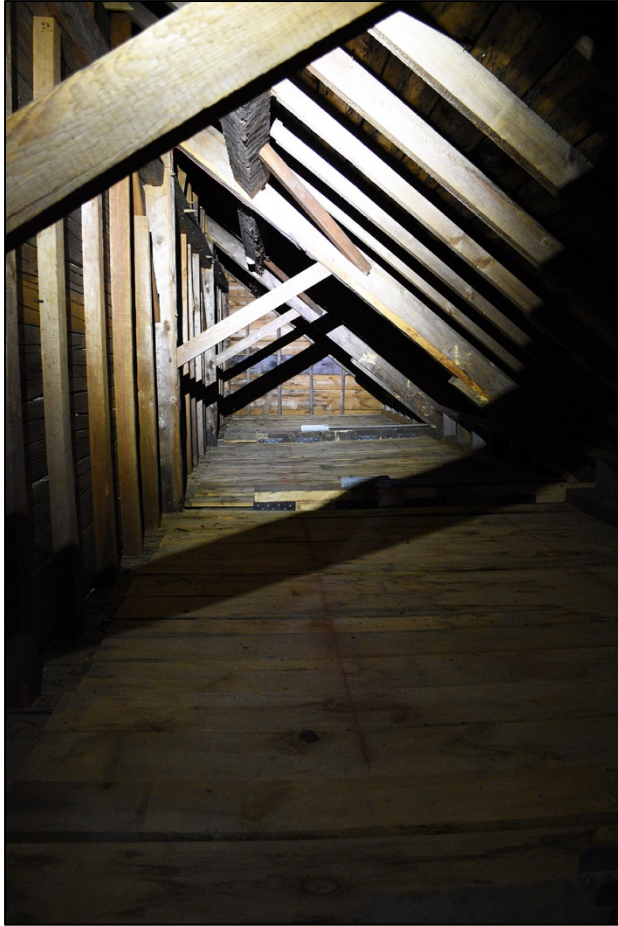
**Figure 38: Northeast eave showing 2006 repairs**

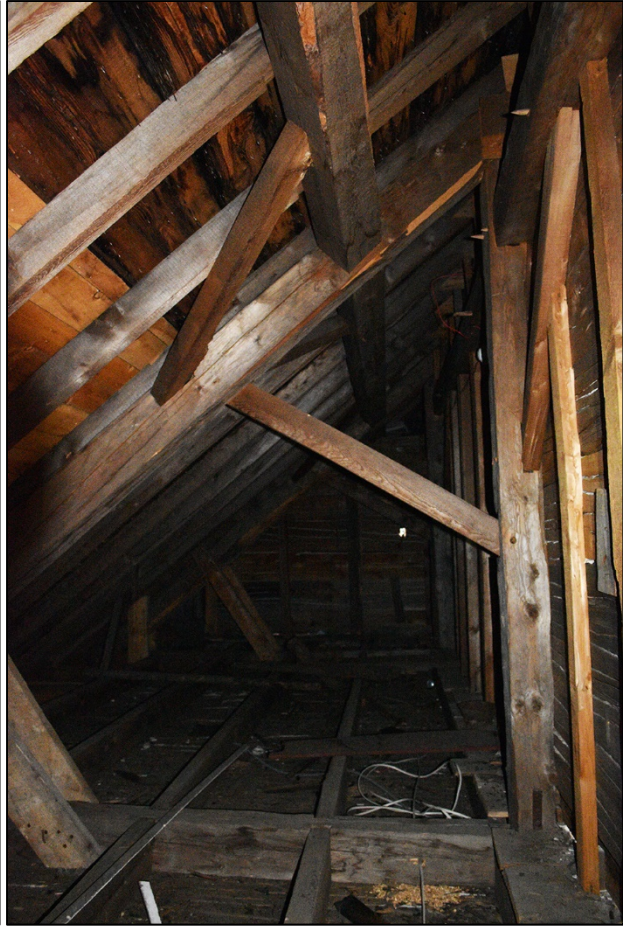
**Figure 39: Unaltered southeast eave**

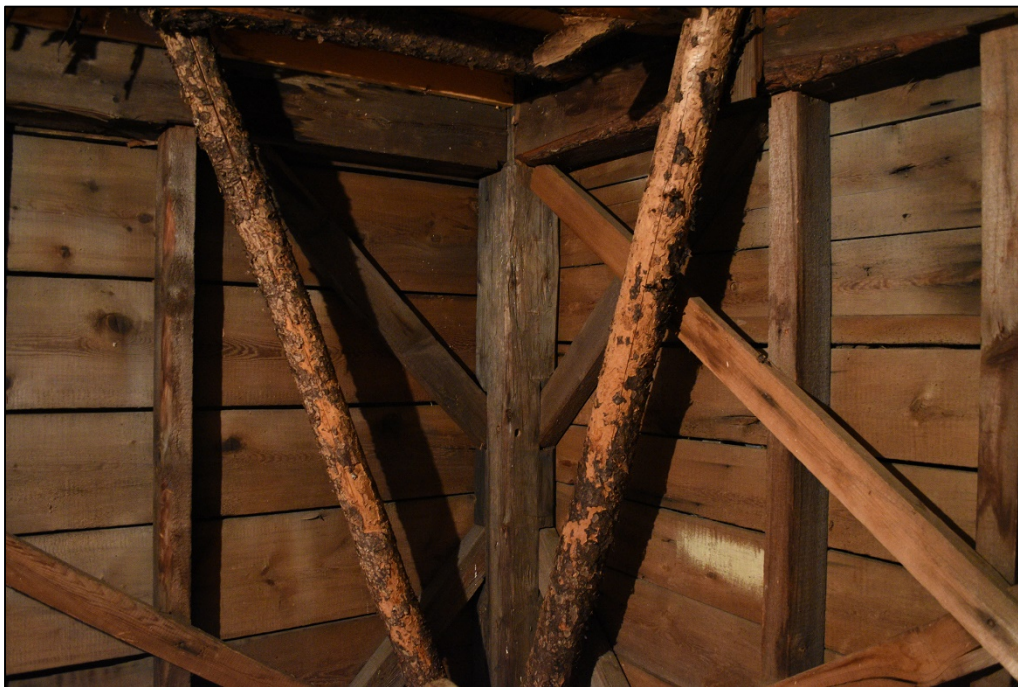
Figure 41: Tower framing

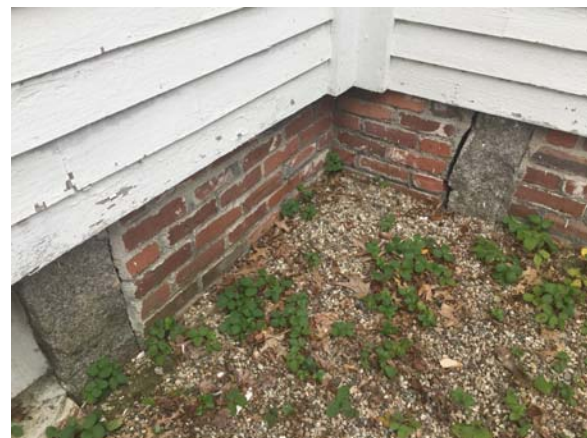
**Figure 13: Unique Building Foundation – Granite posts at perimeter of building with non-structural brick infill masonry**

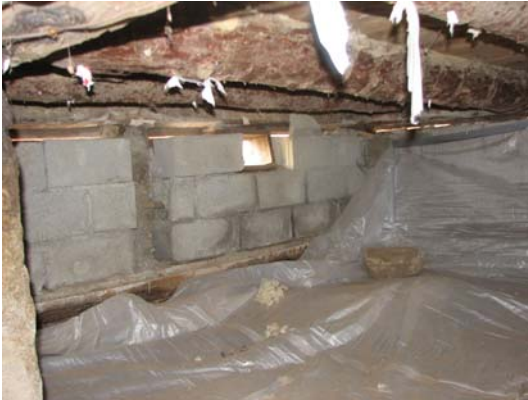
Figure 41 – Infill masonry does not contact building timber sill above, sparing the building frame from frost related damage.

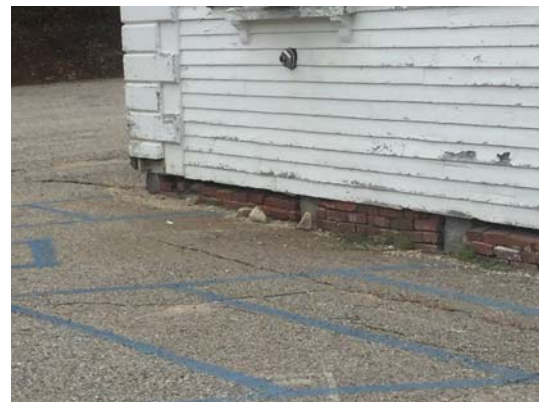
Figure 42 – Overturning infill masonry with extreme mortar wash-out at southwest facade.

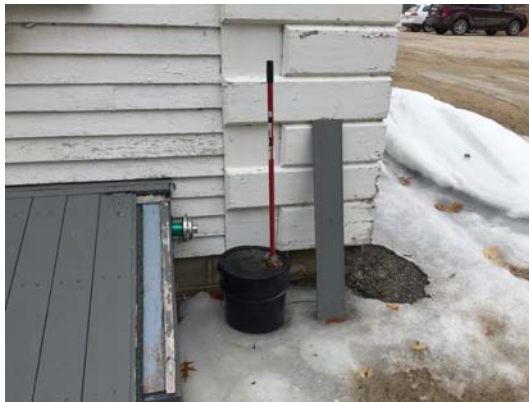
Figure 43 – Original granite pier at north building corner remains. Original masonry has been removed and a small basement space is accessed via bulkhead in need of repair.

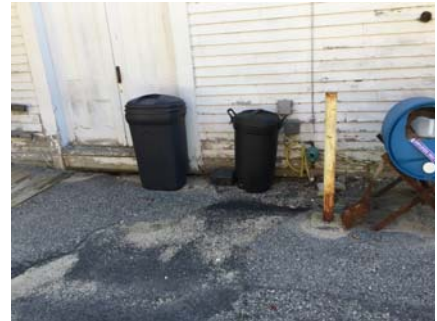
Figure 44 – Wood Clapboard siding (with timber sill behind it) in direct contact with pavement. Investigate for sill damage.

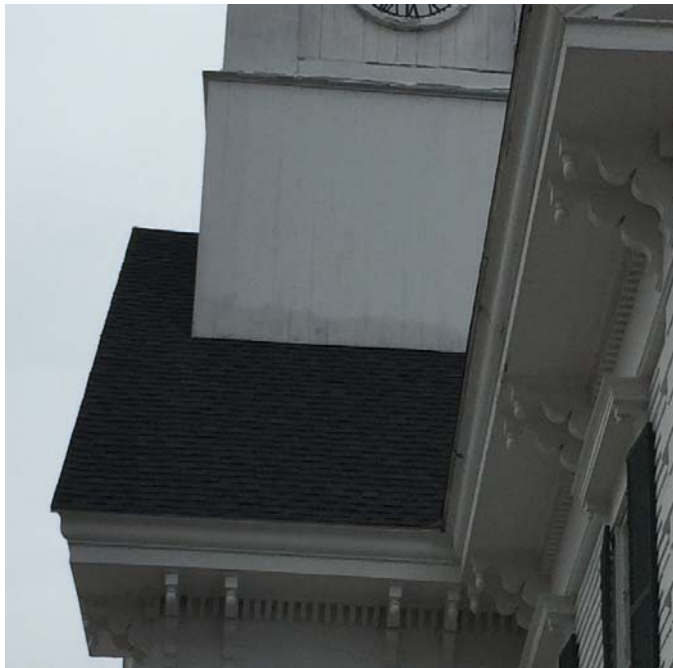
Figure 46 – Staining at tower connection to roof may be related to headwall flashing at double wall

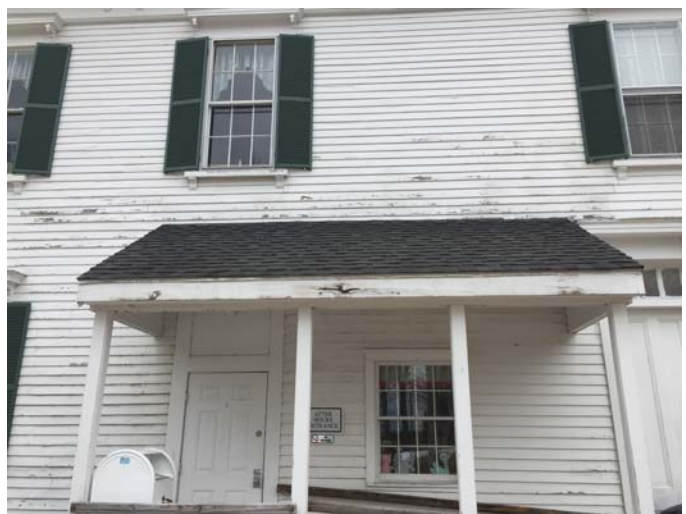
Figure 47– Water damage at porch fascia related to improper drip edge

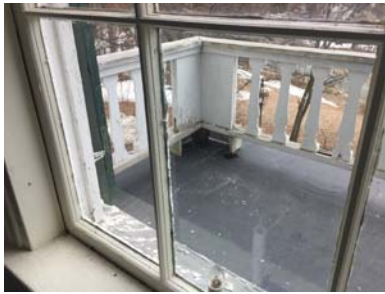
Figure 48– false corner posts at balustrade on entry canopy roof limit penetrations through EPDM roofing

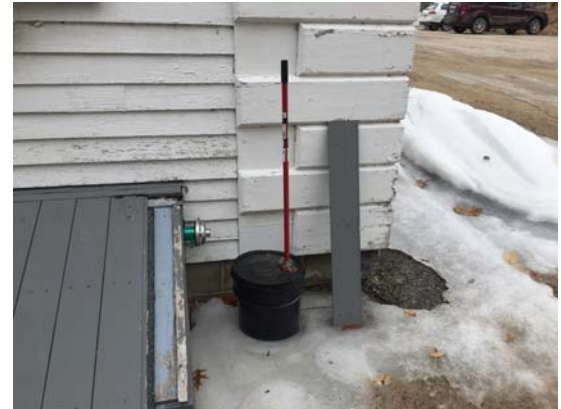
Figure 49 – Asphalt roll roofing on bulkhead covered with failing v-groove pine.

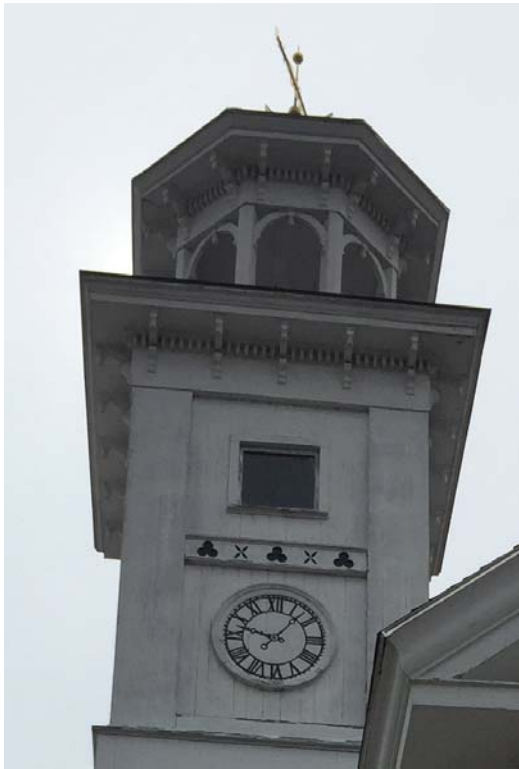
Figure 50 – Rectangular plexiglass windows have replaced original quatrefoil tower windows

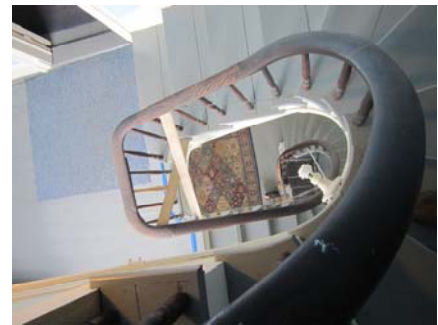
Figure 51 – Stairway in centered entry gable open to Vestibule below

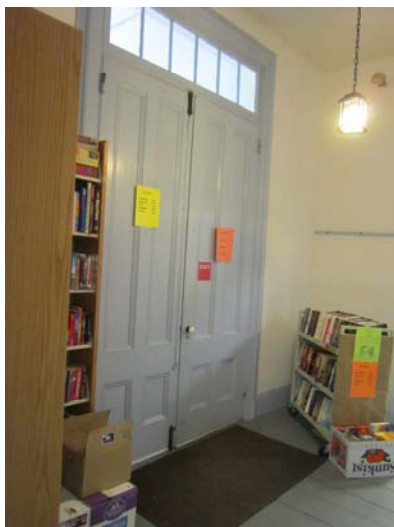
Figure 52 – double doors from vestibule to original hall match fixed exterior doors at northwest facade

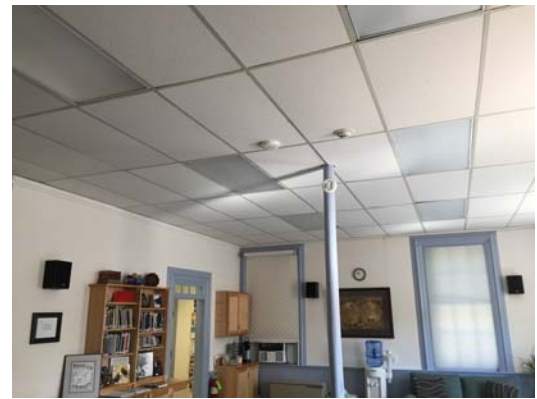
Figure 53– Lay-in acoustical tile ceiling throughout main level supports layer of fiberglass insulation

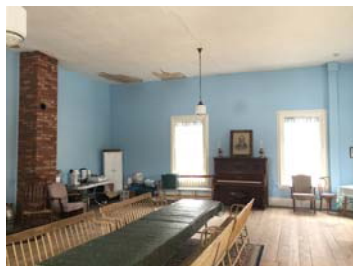
Figure 55– Mason's Meeting Room showing abandoned chimney and extent of damaged ceiling plaster

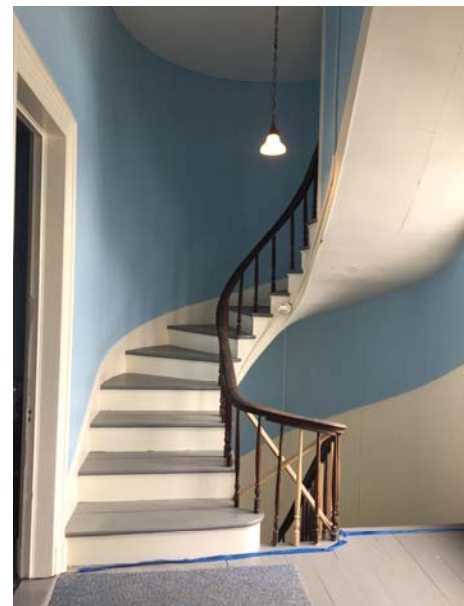
Figure 54 – Delicate open stair with low, curved railing.

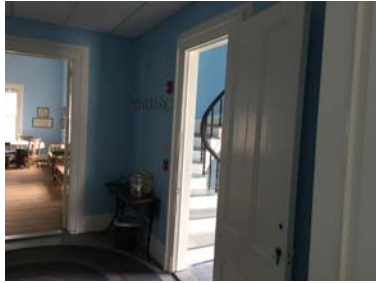
Figure 56— Vestibule, meeting room, and second floor of stairwell beyond.

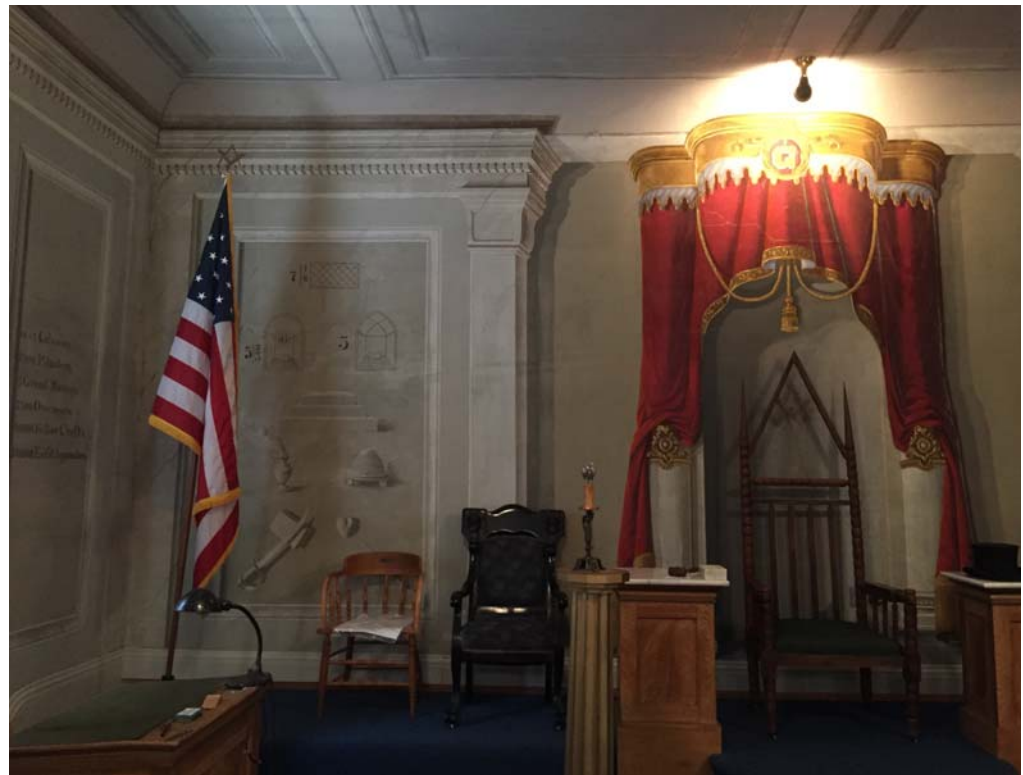
Figure 57 – North corner of Masonic Hall had heavily damaged plaster, now repaired and re-painted

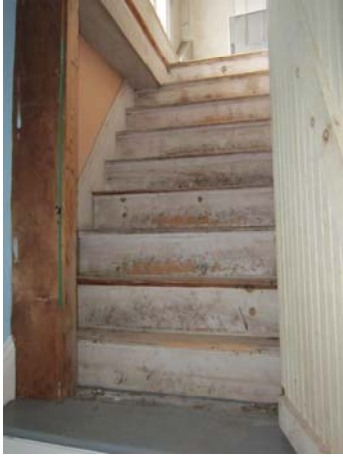
Figure 58 – Steep, enclosed stair at top of open stairway leads to 3<sup>rd</sup> floor

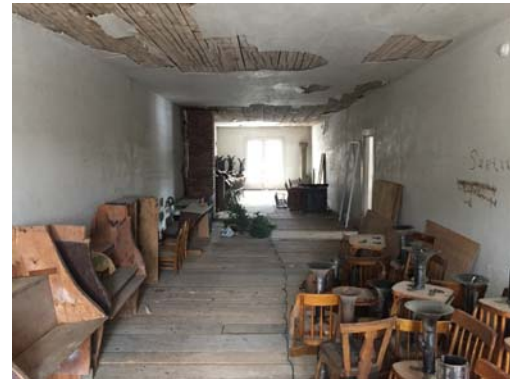
Figure 59 – Attic room has become a town repository and a de facto graffiti museum

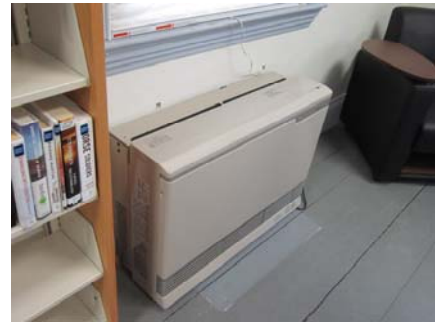
Figure 60 – Typical through-wall propane heater

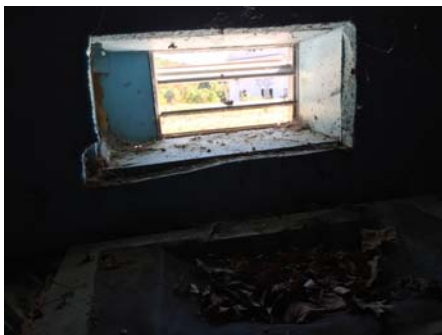
Figure 61 – louvered vents in crawlspace should be fitted with insulated covers for use in the heating season

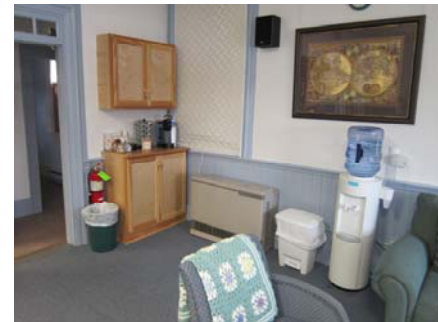
Figure 62– Replace propane fueled heaters with heat pumps for efficiency, cooling, and moisture control

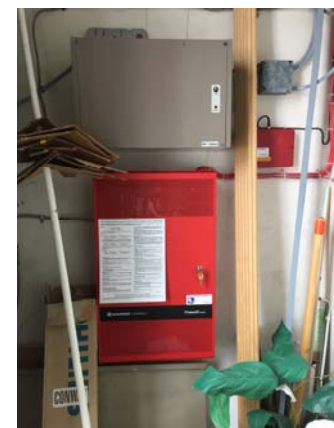
Figure 64 – Fire alarm panel located in Vestibule

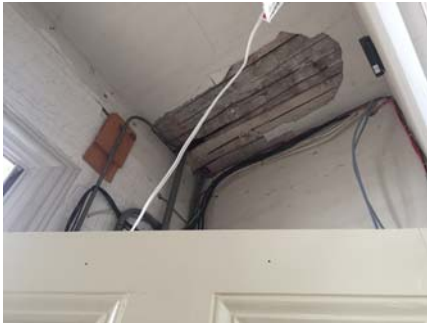
Figure 65 – Penetrations where pipes and wiring pass through corridor walls should be firestopped.

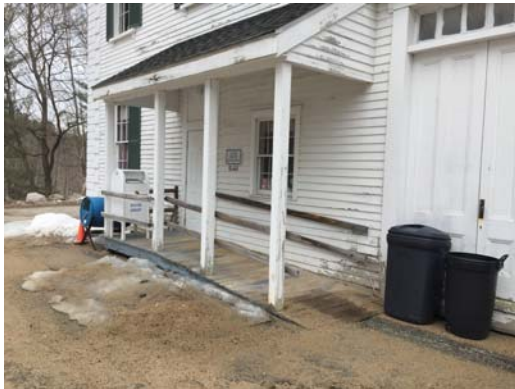
Figure 67– Entry ramp lacks adequately-sized top landing and proper handrails

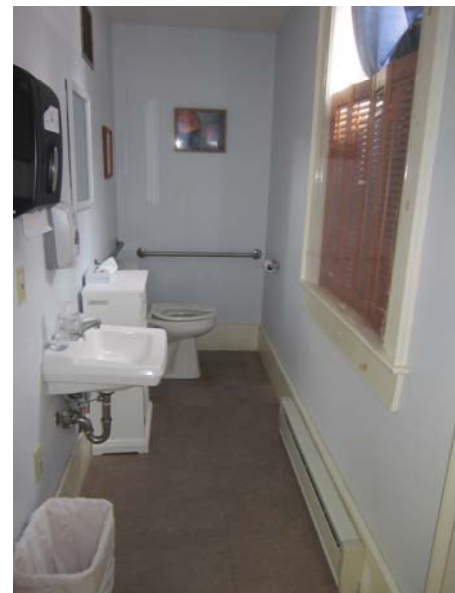
Figure 68– Existing restrooms are too narrow to meet ADA requirements for turning

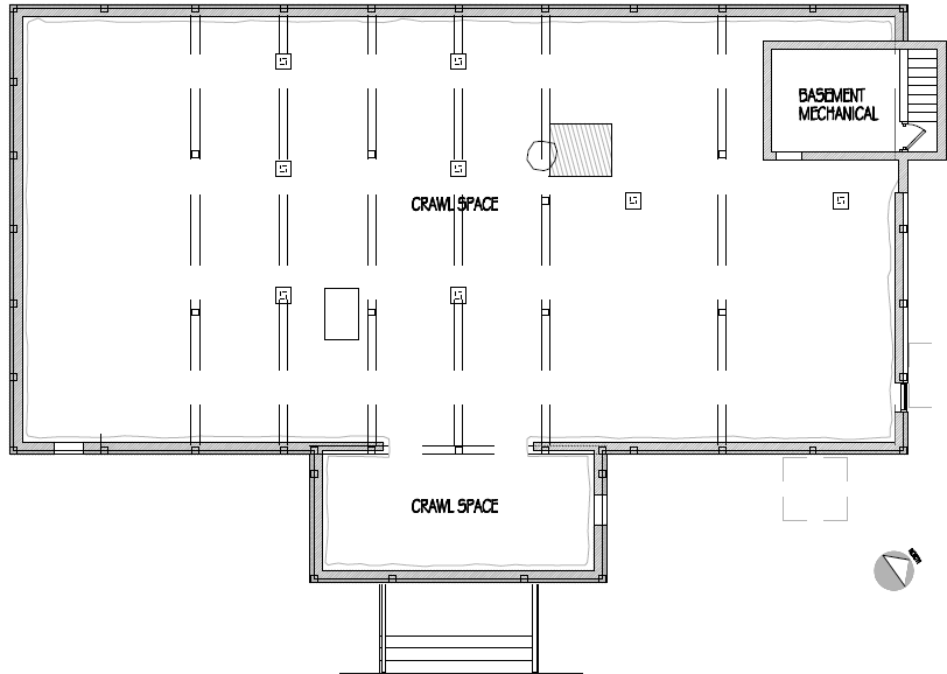
*Basement / Crawl Space Plan*

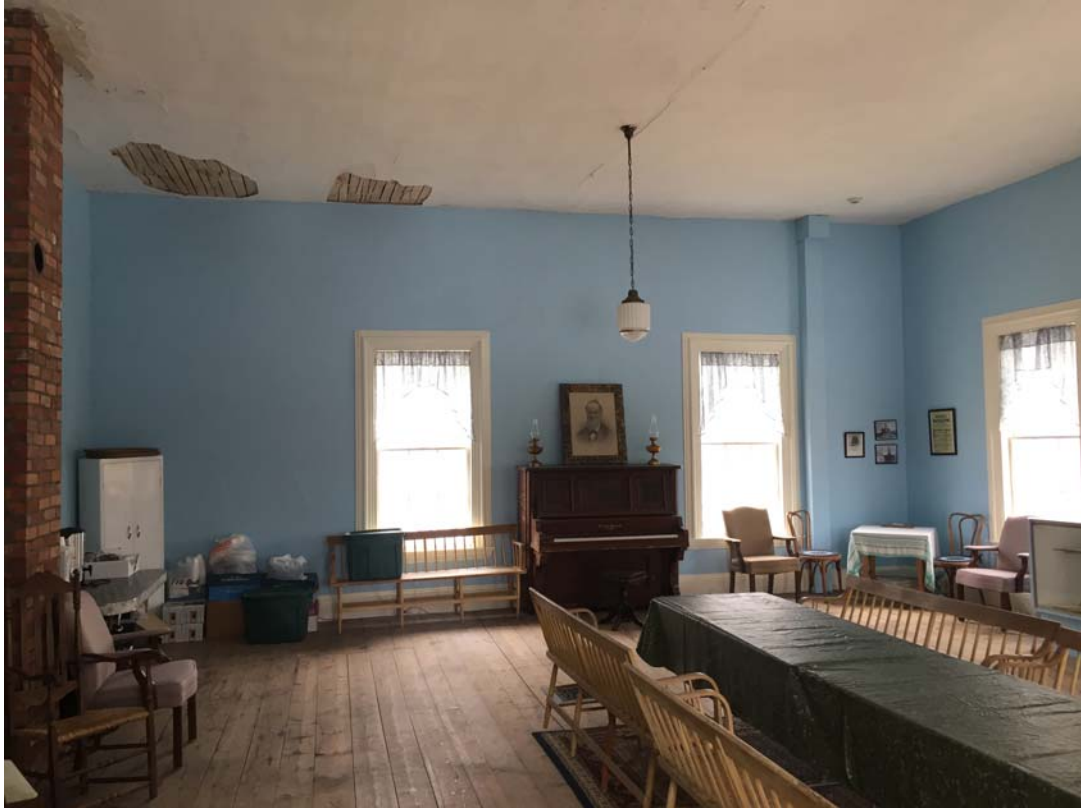
Mason's Meeting room showing Plaster Failures at Ceiling

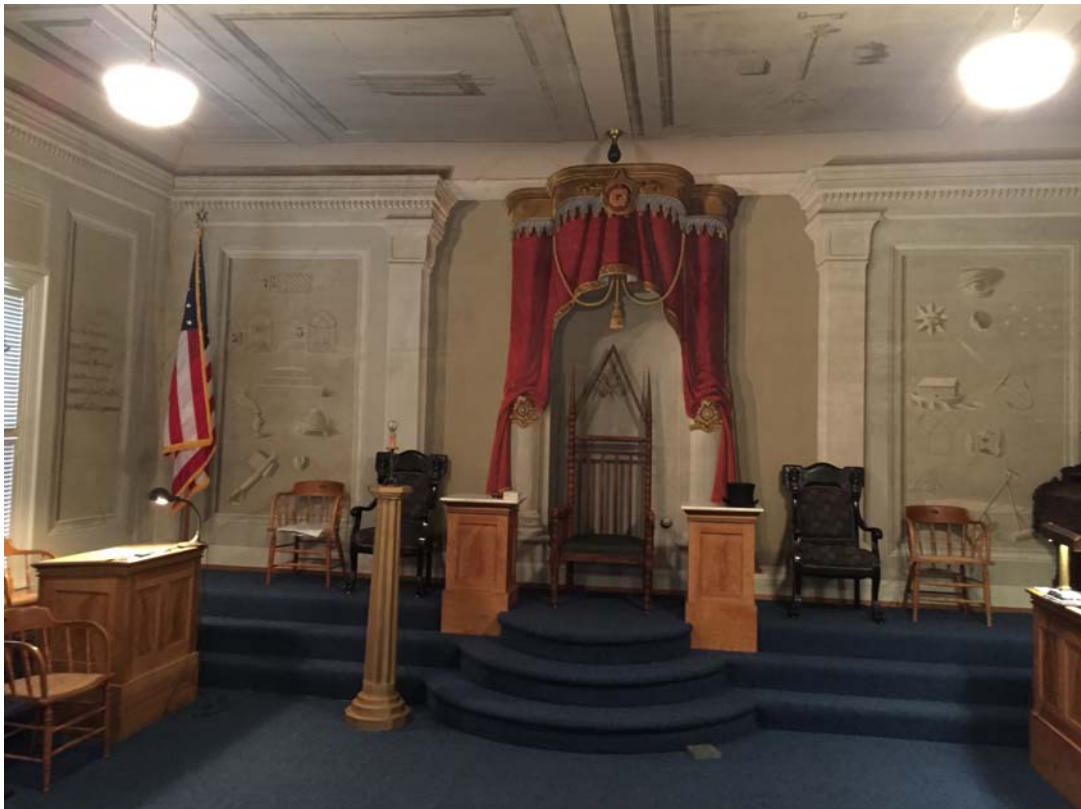
Restored Trompe l'oeil murals painted ca. 1860 on flat plaster of Masonic Hall

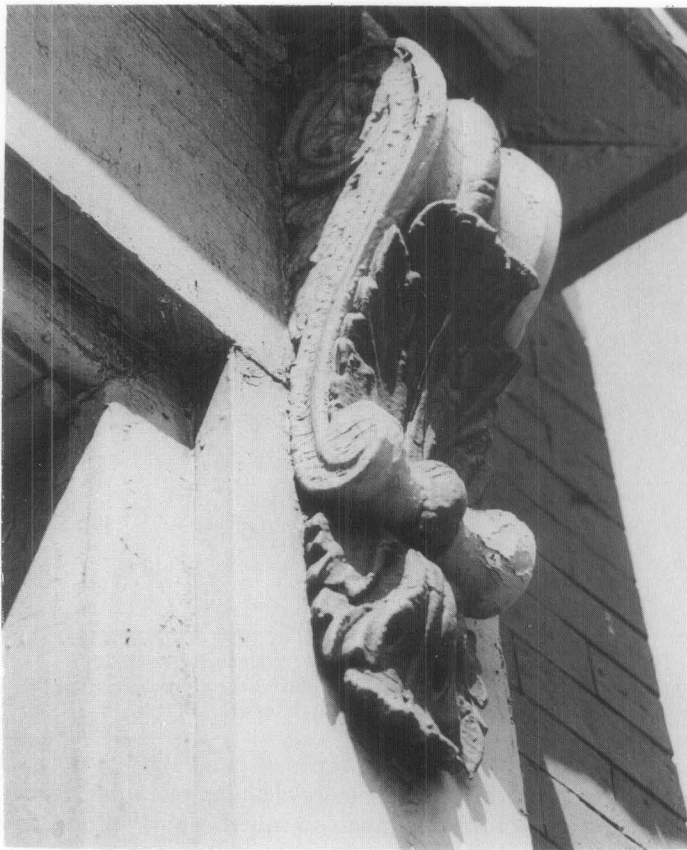
Fig. 1 Excessive paint build-up on architectural details such as this ornamental bracket does not in itself justify total paint removal. If paint is cracked and peeling down to bare wood, however, it should be removed using the gentlest means possible. Photo: David W. Look, AIA.

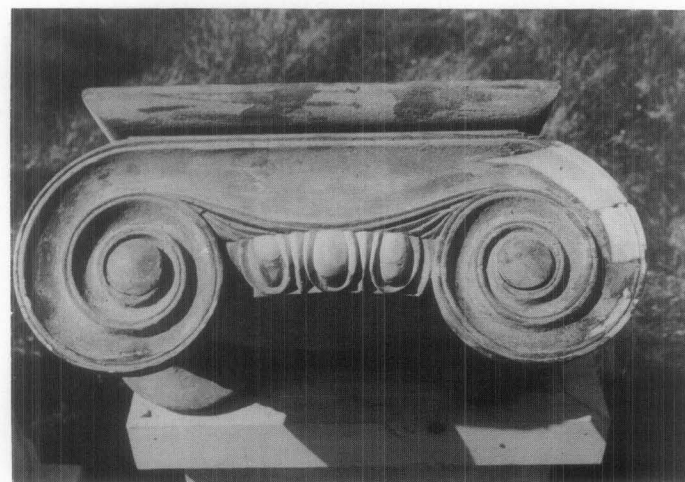
Fig. 3 If damage to parts of a wooden element is severe, new sections of wood will need to be pieced-in. When such piecing is required, paint on the adjacent woodwork should be removed so that the old and new woods will make a smooth profile when joined. After repainting, the repair should be virtually impossible to detect. Photo: Morgan W. Phillips.

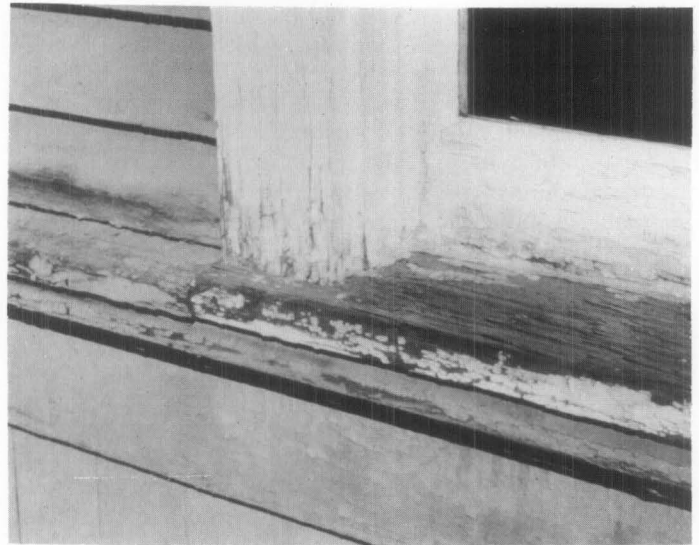
Staining of paint coatings usually results from excess

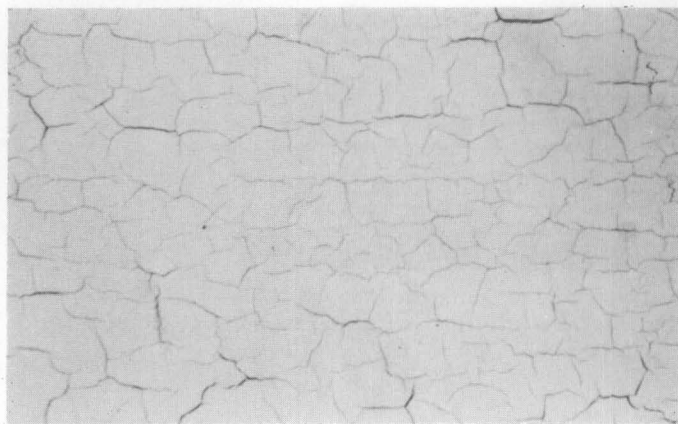
Fig. 5 Crazing—or surface cracking—is an exterior surface condition which can be successfully treated by sanding and painting. Photo: Courtesy, National Decorating Products Association.

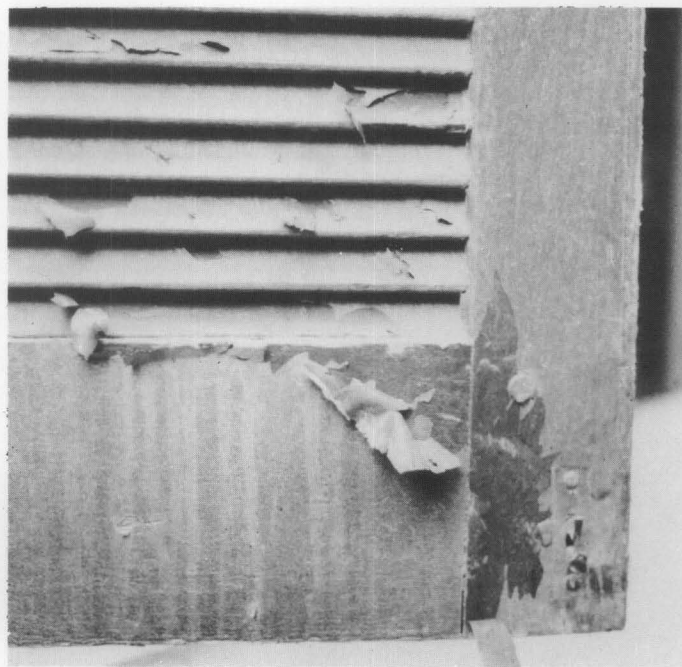
Fig. 6 This is an example of intercoat peeling. A latex top coat was applied directly over old oil paint and, as a result, the latex paint was unable to adhere. If latex is being used over oil, an oil-base primer should be applied first. Although much of the peeling latex paint can be scraped off, in this case, the best solution may be to chemically dip strip the entire shutter to remove all of the paint down to bare wood, rinse thoroughly, then repaint. Photo: Mary L. Oehrlein, AIA.
