**CHRISTOPHER P. WILLIAMS ARCHITECTS, PLLC**  
**PO Box 703 · Meredith, New Hampshire 03253 · 603-279-6513**

**Historic Building Assessment with Preservation Guidelines**

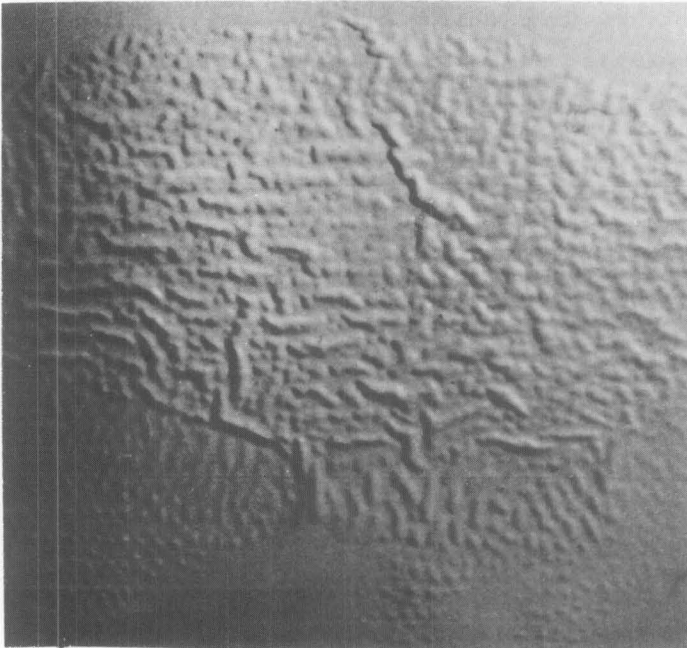
Fig. 7 Wrinkled layers can generally be removed by scraping and sanding as opposed to total paint removal. Following manufacturers' application instructions is the best way to avoid this surface condition. Photo: Courtesy, National Decorating Products Association.

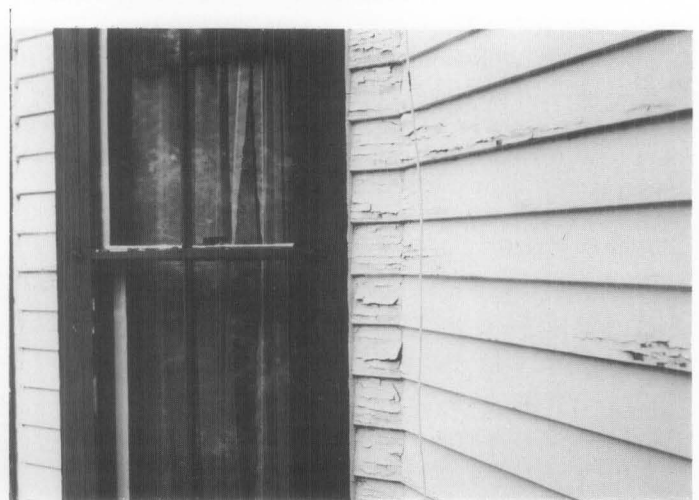
Fig. 8 Peeling to bare wood—one of the most common types of paint failure—is usually caused by an interior or exterior moisture problem. Photo: Anne E. Grimmer.

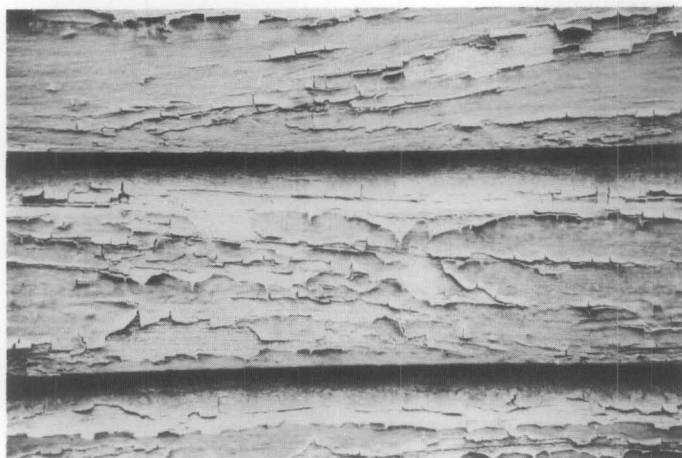
Fig. 9 Cracking, alligatoring, and flaking are evidence of long-term neglect of painted surfaces. The remaining paint on the clapboard shown here can be removed with an electric heat plate and wide-bladed scraper. In addition, unsound wood should be replaced and moisture problems corrected before primer and top coats of paint are applied. Photo: David W. Look, AIA.

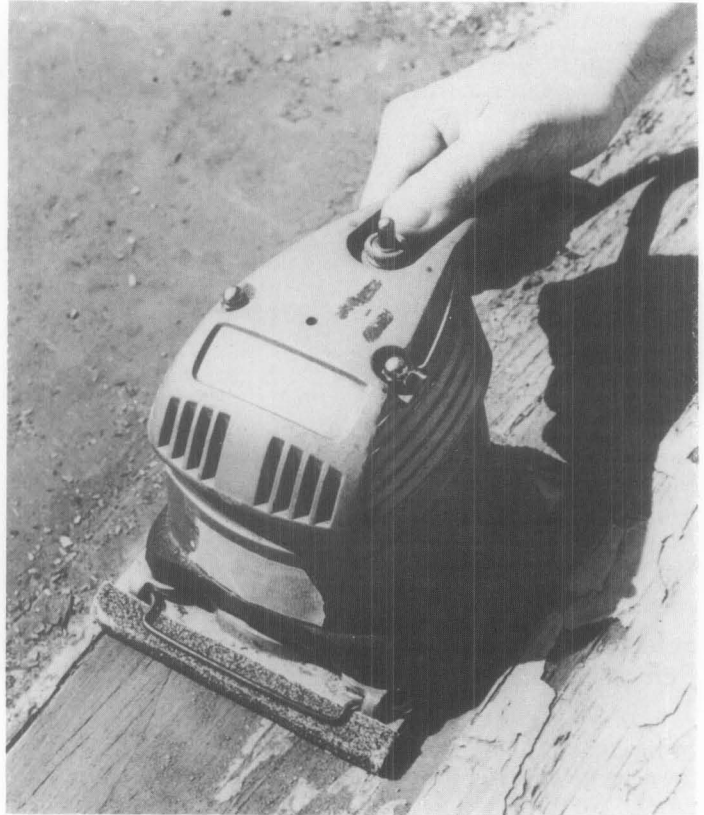
Fig. 11 The orbital sander can be used for limited paint removal, i.e., for smoothing flat surfaces after the majority of deteriorated paint has already been scraped off. Photo: Charles E. Fisher, III.

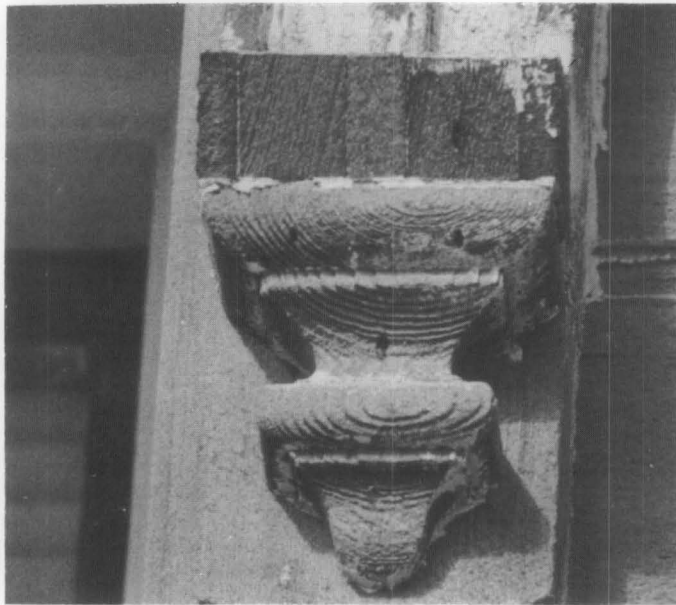
Fig. 12 Sandblasting has permanently damaged this ornamental bracket. Even paint will not be able to hide the deep erosion of the wood. Photo: David W. Look, AIA.

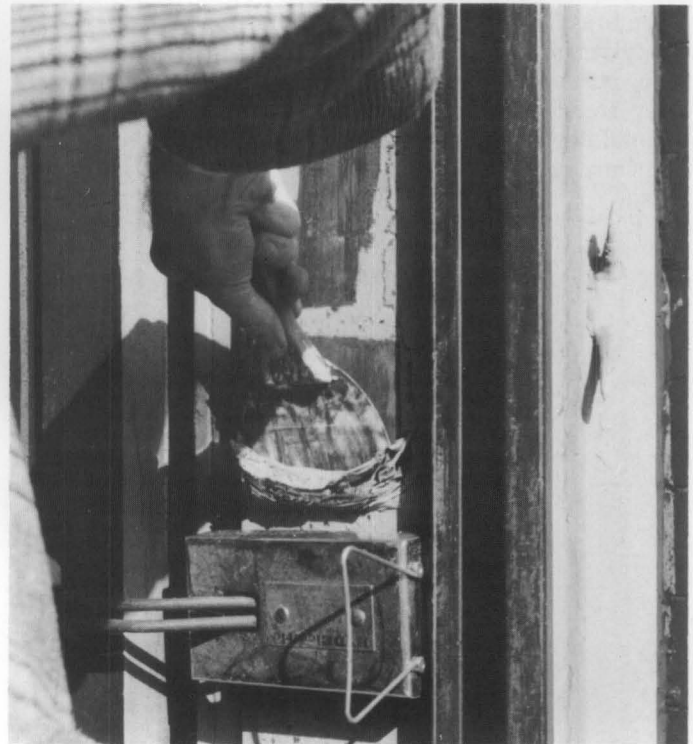
Fig. 13 The electric heat plate (with paint scraper) is particularly useful for removing paint down to bare wood on flat surfaces such as doors, window frames, and siding. After scraping, some light sanding will probably be necessary to smooth the surface prior to application of primer and top coats. Photo: David W. Look, AIA.

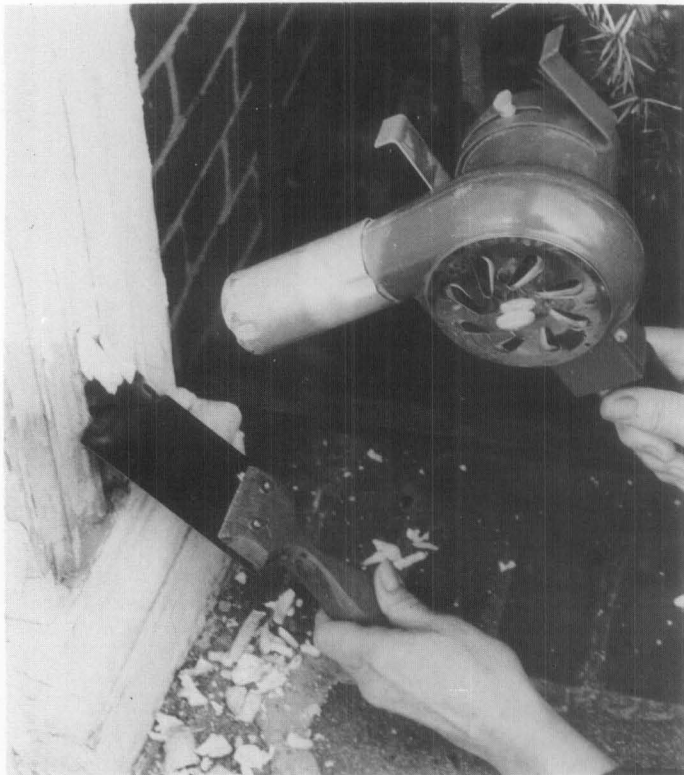
Fig. 14 The nozzle on the electric heat gun permits hot air to be aimed into cavities on solid decorative elements such as this applied column. After the paint has been sufficiently softened, it can be removed with a profiled scraper. Photo: Charles E. Fisher, III.
